Manhole Inspection Summary

Manhole # S29CC2005MH

Insp Date: **12/7/06 1:13 PM**

Location Address: **10 TANWORTH RD**

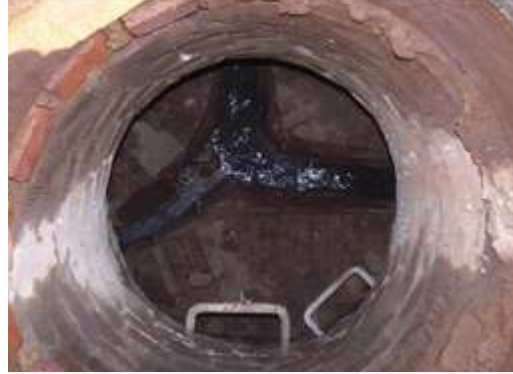
Top View

Evidence of surcharge - Bench debris.

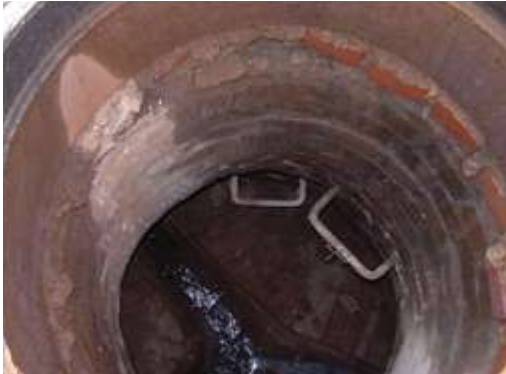
Defect

☒ **Leaks**

Condition: ☐ Sound ☐ Cracked ☐ Root Intrusion ☐ Loose Brick ☒ **Deteriorated**

Infiltration: ☐ None ☒ **Joint** ☐ Cracks ☒ **Mortar** ☐ Roots ☒ **Wall**

Frame leaks. Frame offset. Adjustment deterioration and infiltration. Barrel infiltration.

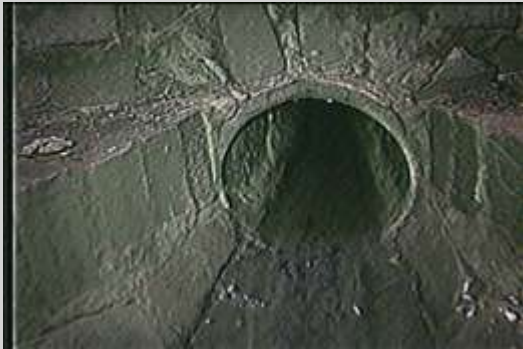
Pipe Out @ 12 O'Clock

Infiltration: **Evidence** Pipe Seal Cond: **Cracked**

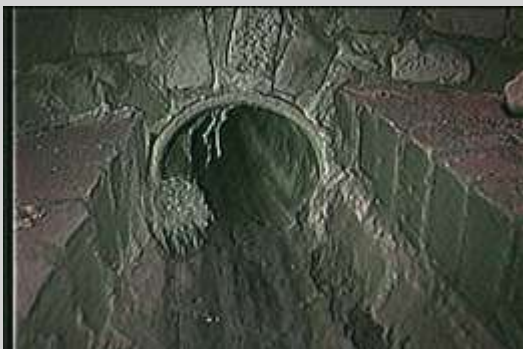
Pipe In @ 3 O'Clock

Infiltration: **Evidence** Pipe Seal Cond: **Roots**

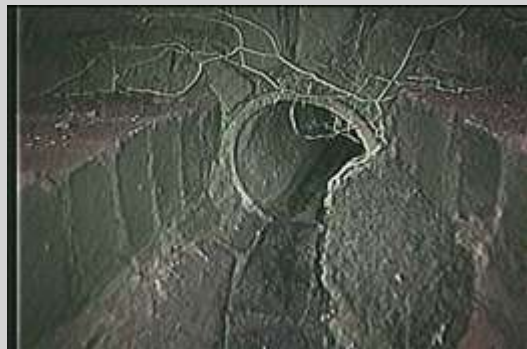
Pipe In @ 7 O'Clock

Barrel deterioration, root intrusion and infiltration. Channel deterioration and root intrusion.

Infiltration: **Evidence** Pipe Seal Cond: **Roots**
